FATAL CRANE INCIDENT 22nd October 2007

Germano Construction Site Brazil

LESSONS LEARNED

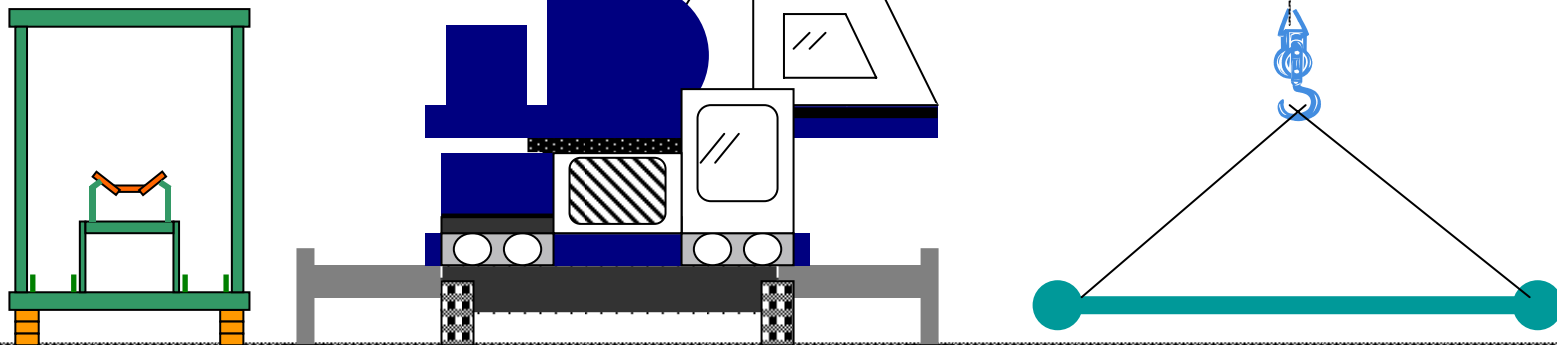
Boom length – 26.6 m

Radius – 4.0 m

Max Lifting capacity – 20 t

Weight of load – 14.2 t

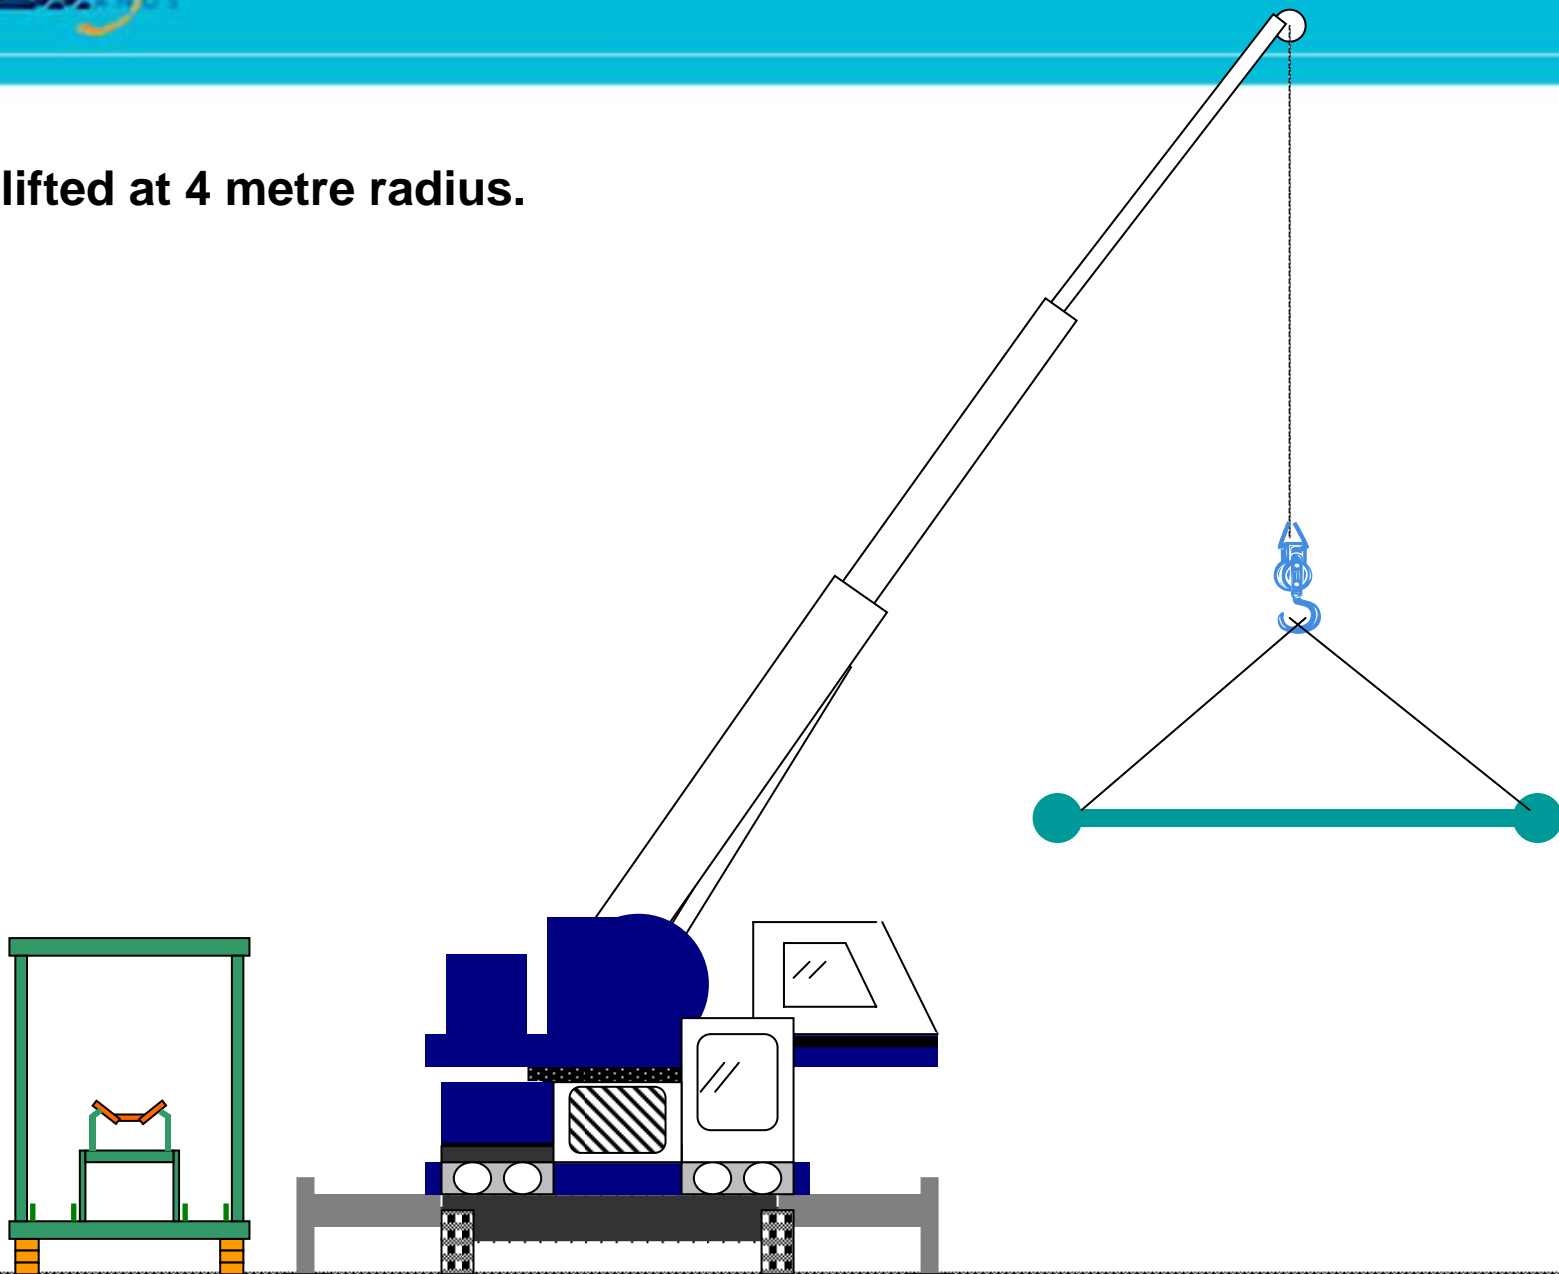
Load is lifted at 4 metre radius.

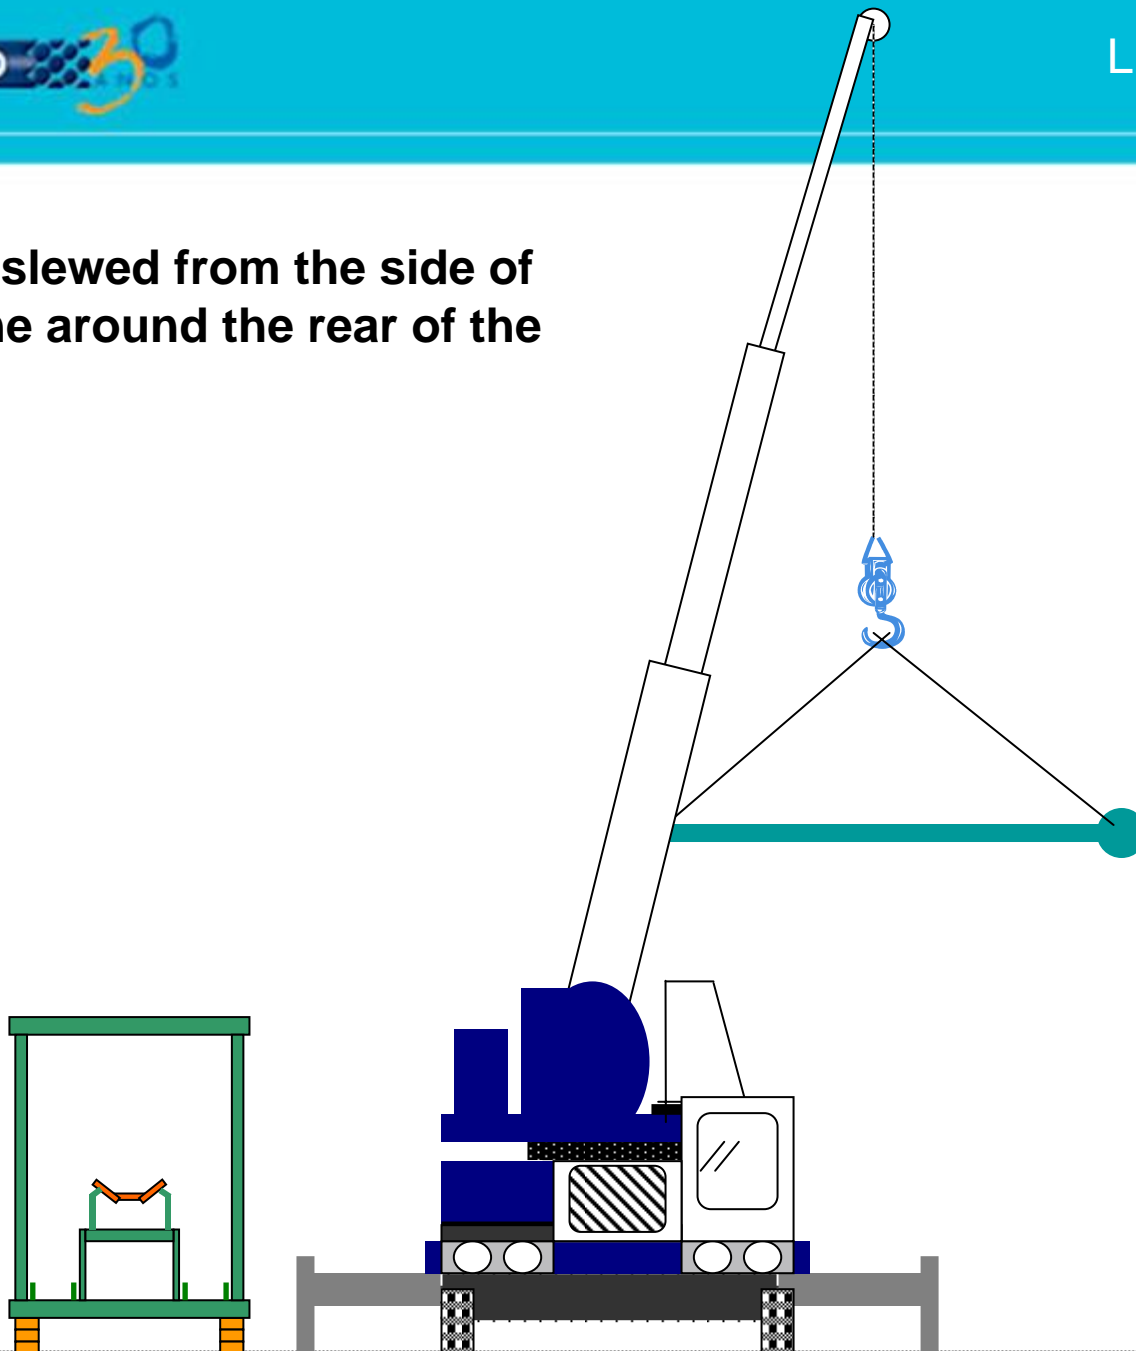
Load is slewed from the side of the crane around the rear of the crane.

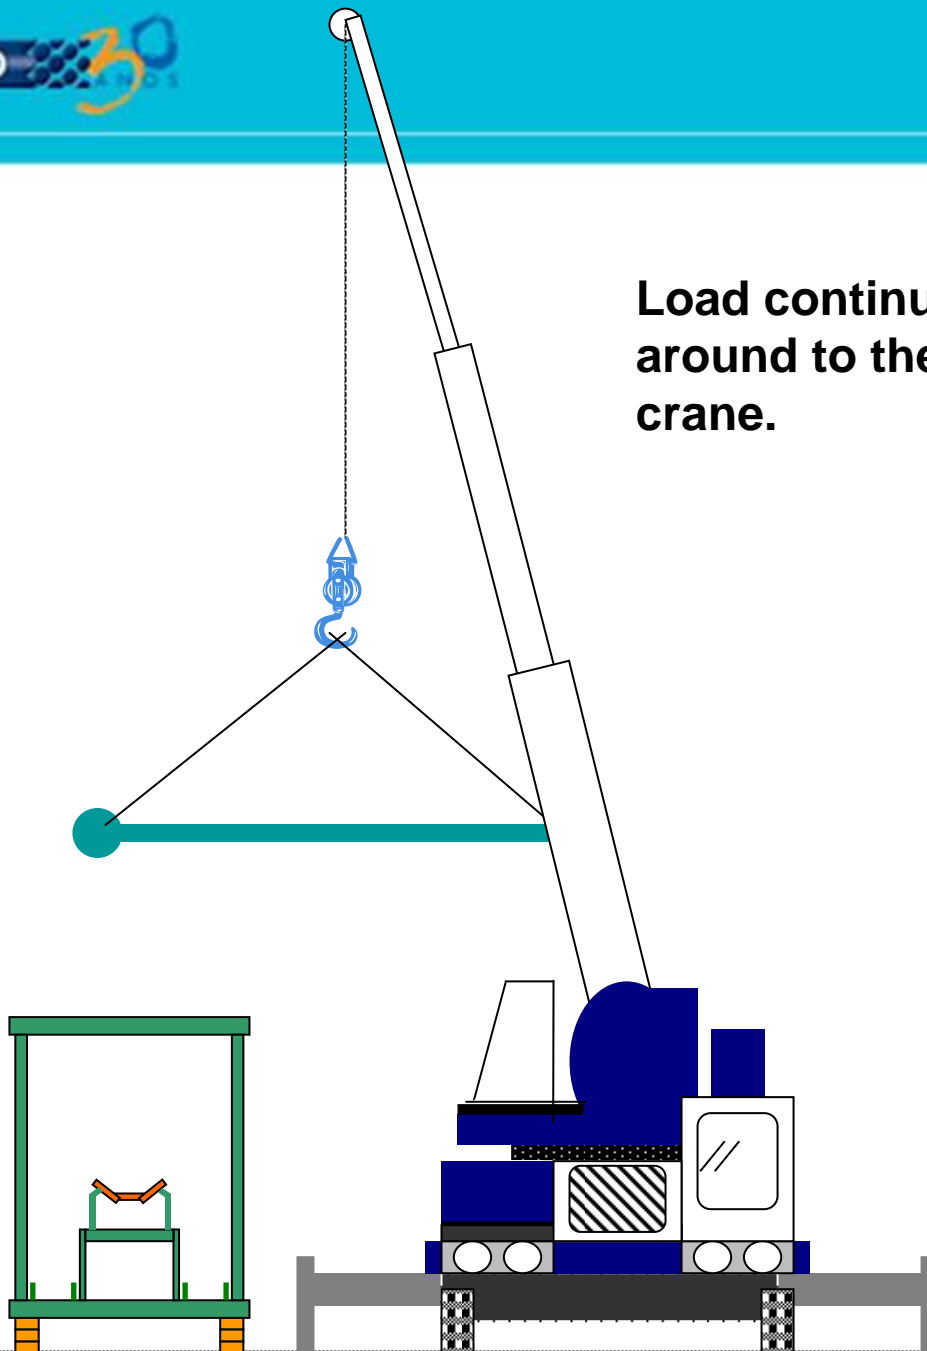
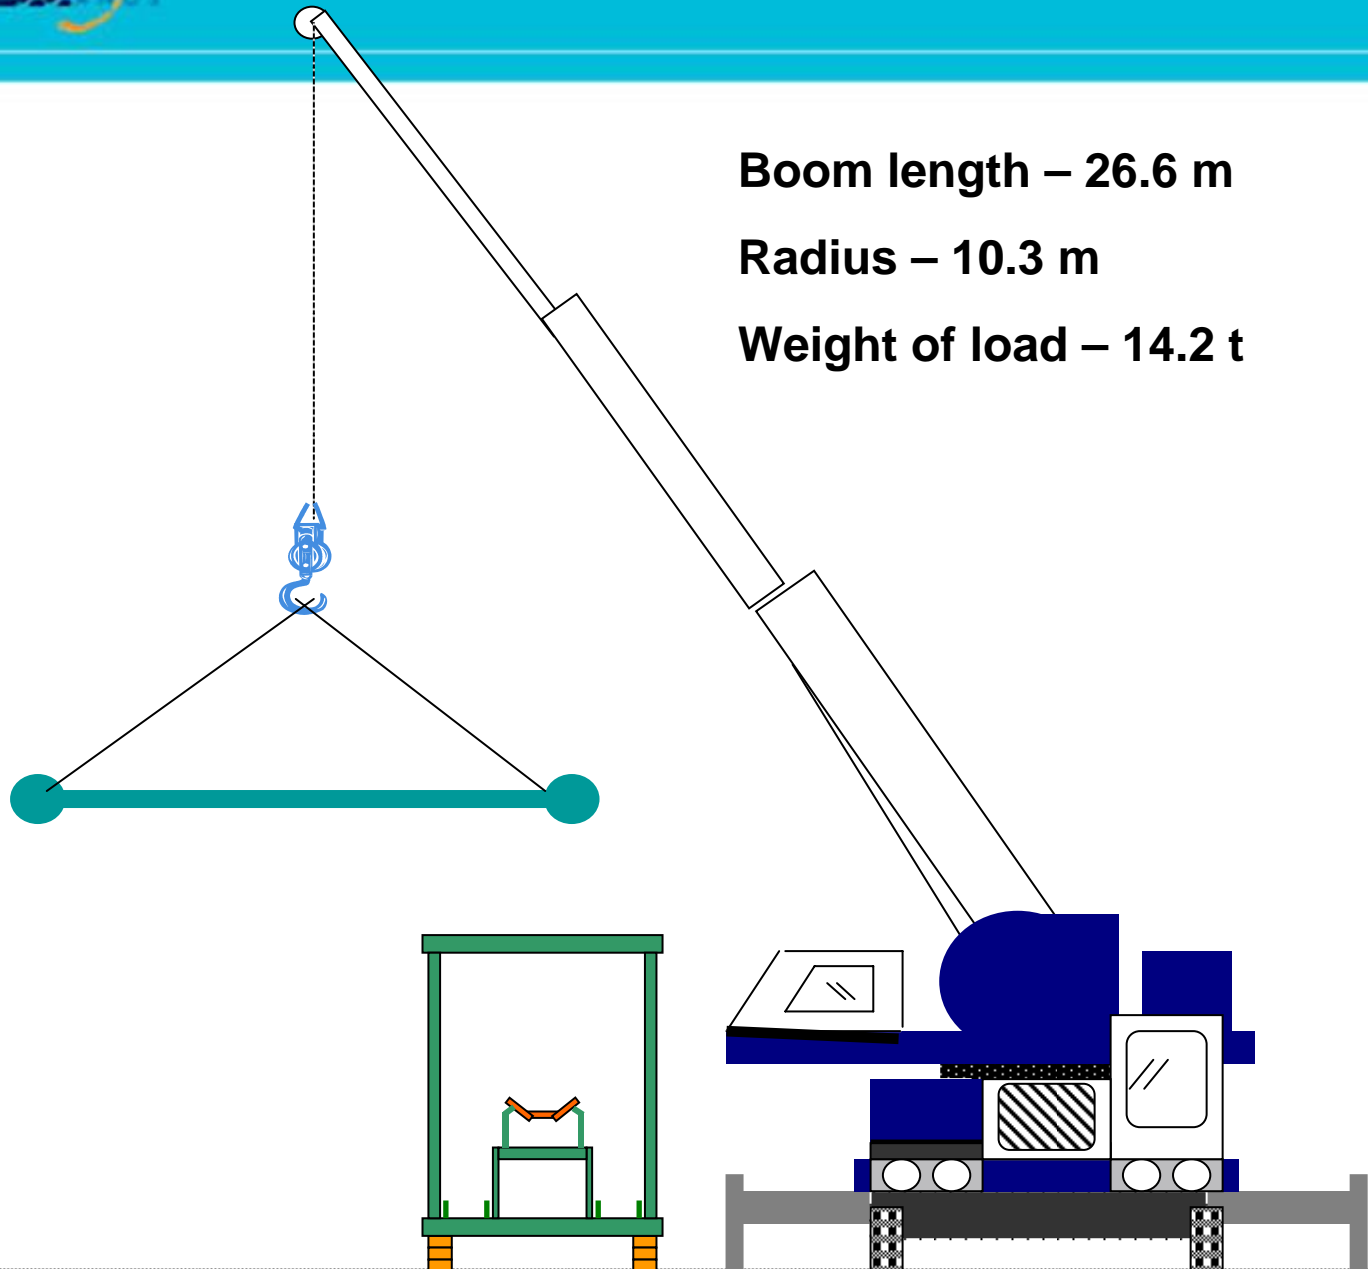
Load continues to be slewed around to the other side of the crane.

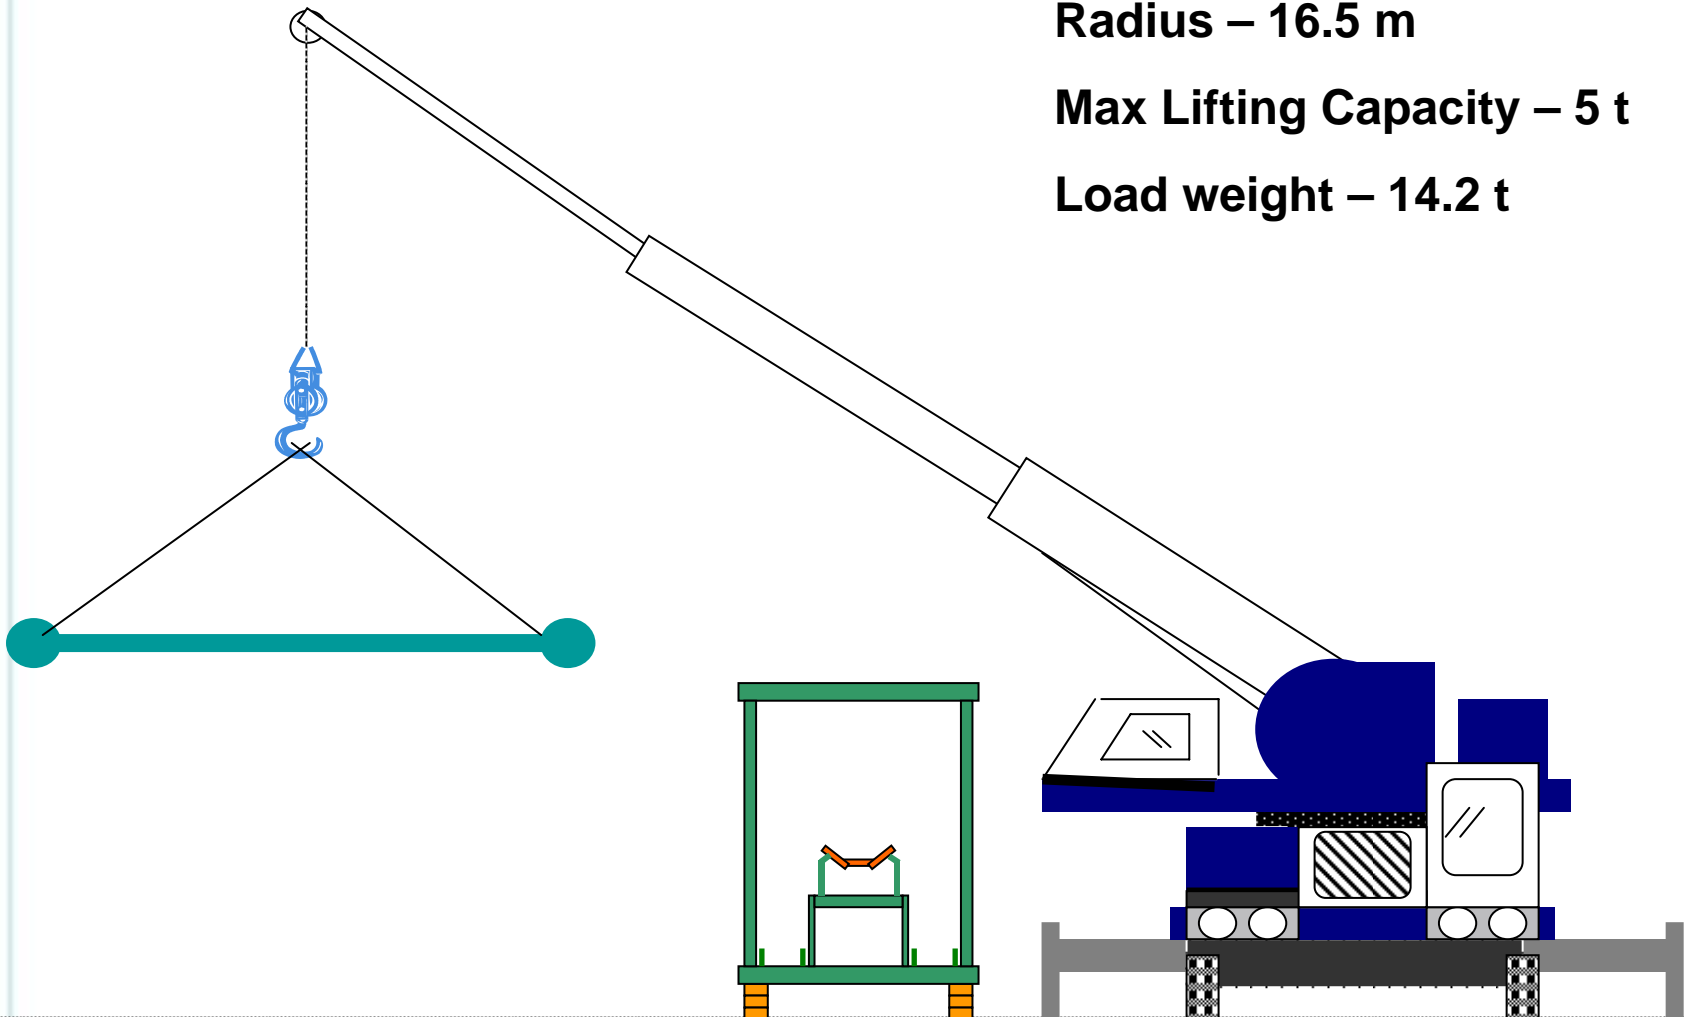
Boom length – 26.6 m

Radius – 16.5 m

Max Lifting Capacity – 5 t

Load weight – 14.2 t

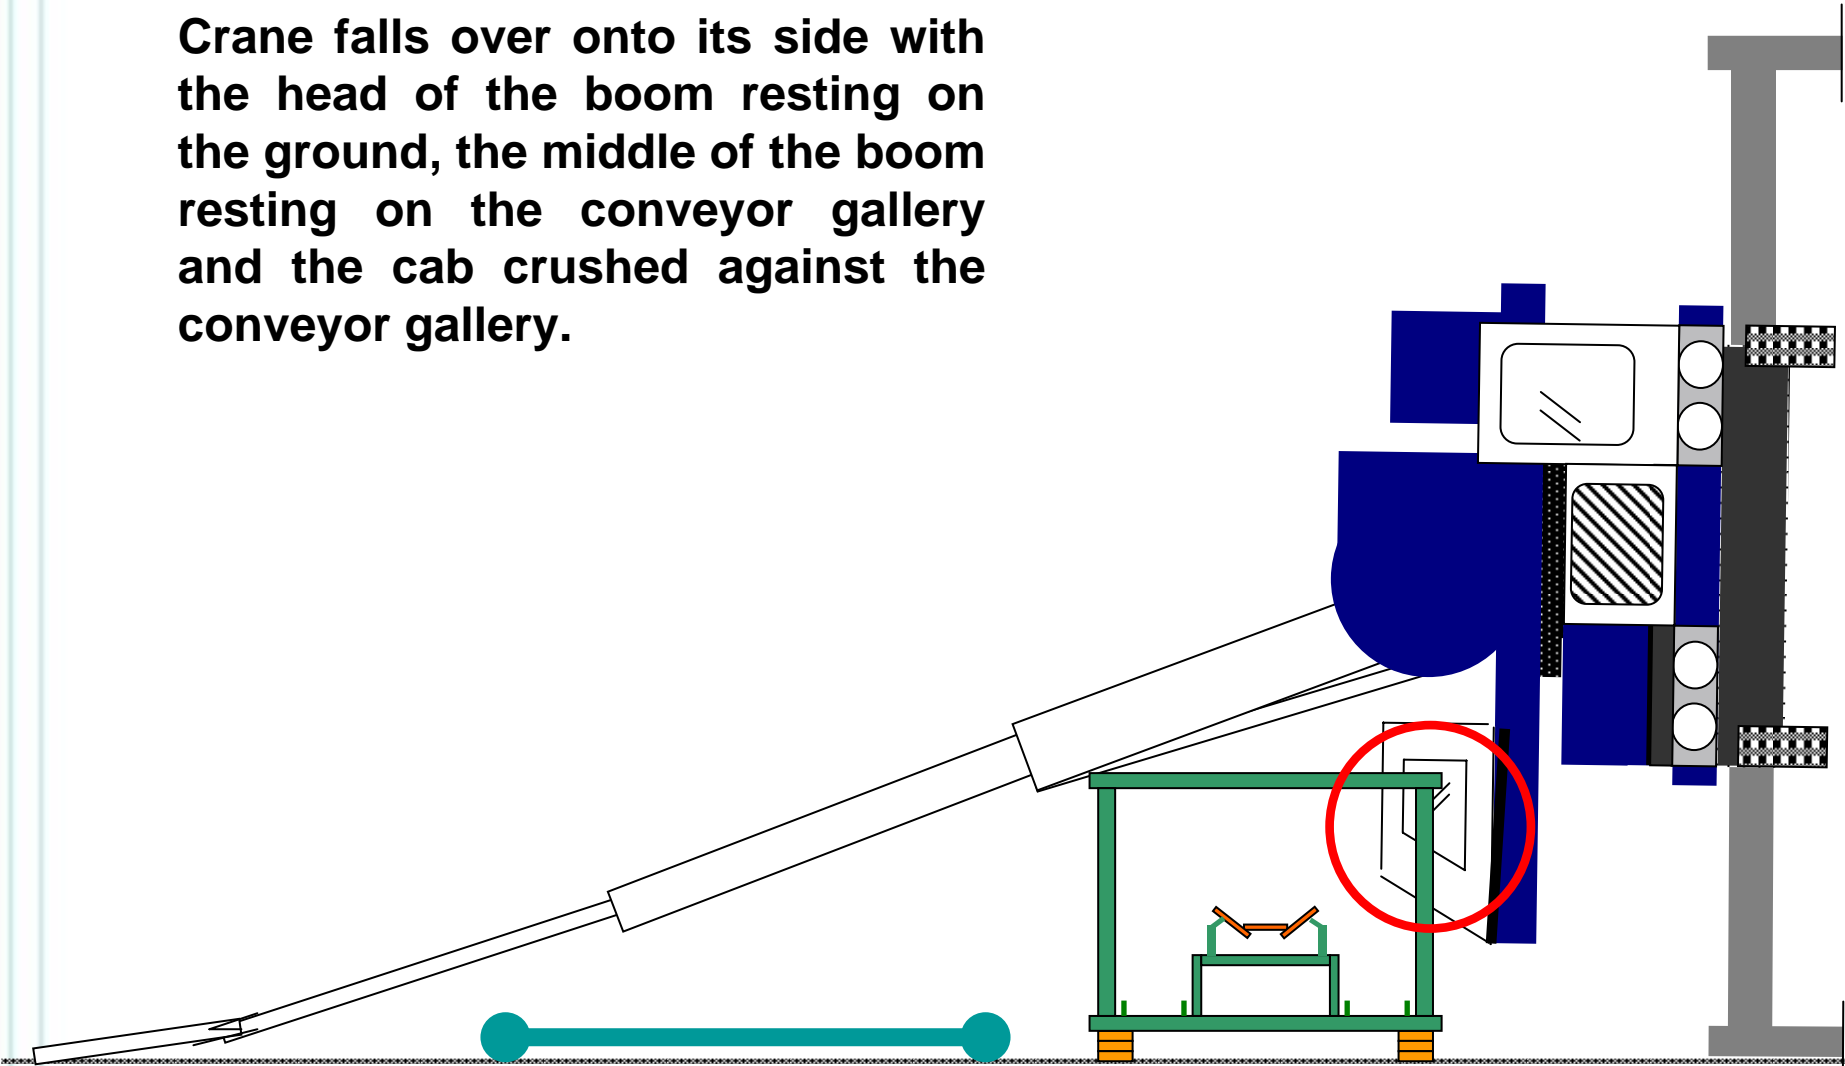
Crane falls over onto its side with the head of the boom resting on the ground, the middle of the boom resting on the conveyor gallery and the cab crushed against the conveyor gallery.

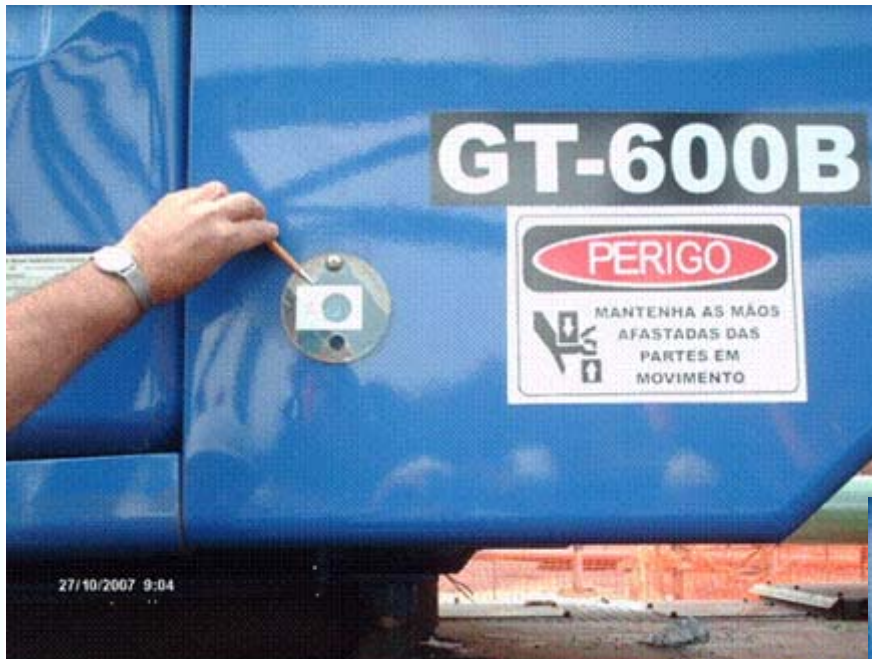
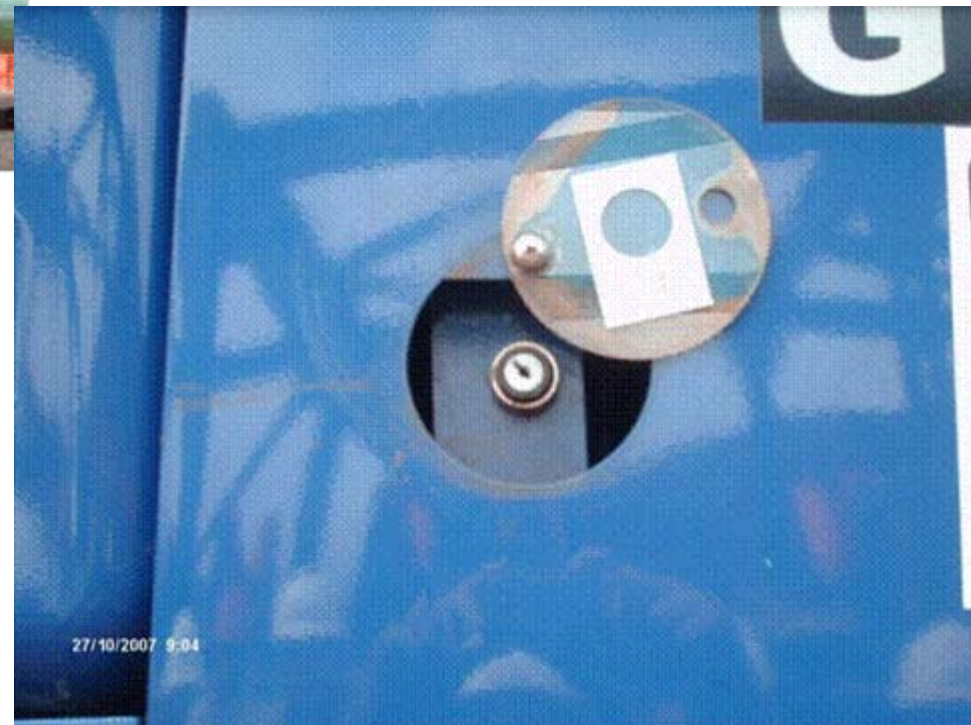
The automatic safety interlocks for the crane operation were immobilised at the key outside of the operators cab by the crane operator.

1.	The computers in all site cranes (where fitted) have their data downloaded to investigate if the overloading of cranes is a general violation or restricted to this crane operator.
2.	Emergency bypass controls are to be locked in the off position at all times.
3.	Crane operators are to ensure that the all emergency bypass controls are locked in the off position at the Start of each shift.
4.	Supervision is to inspect all emergency bypass controls during each shift to ensure they are locked in the off position.
5.	Crane operational data from the onboard computer is to be downloaded each month to review the safe use and operation of the crane for the month.

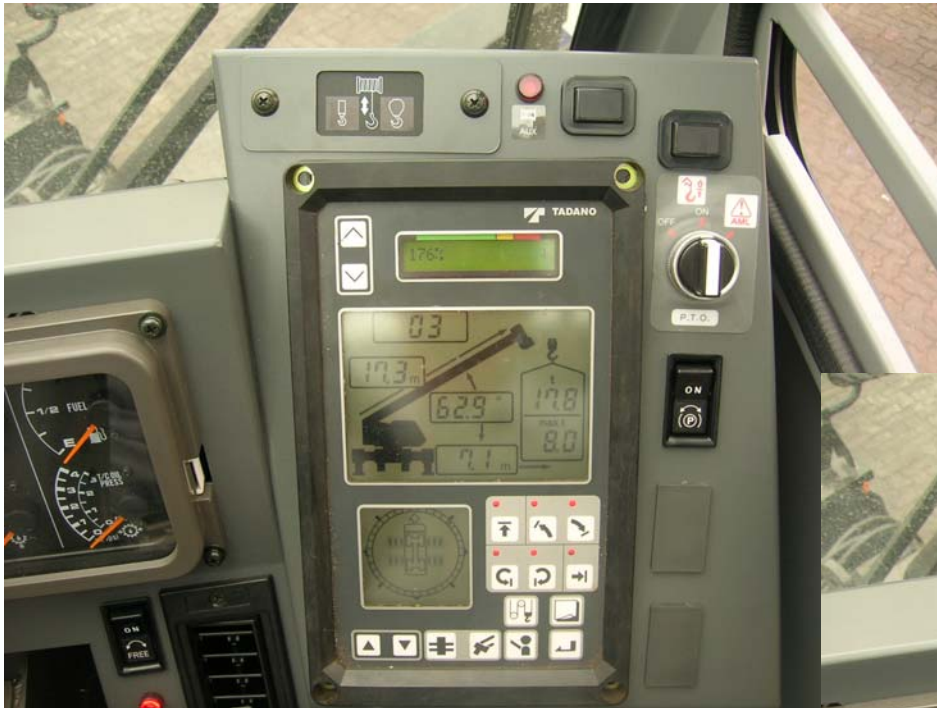
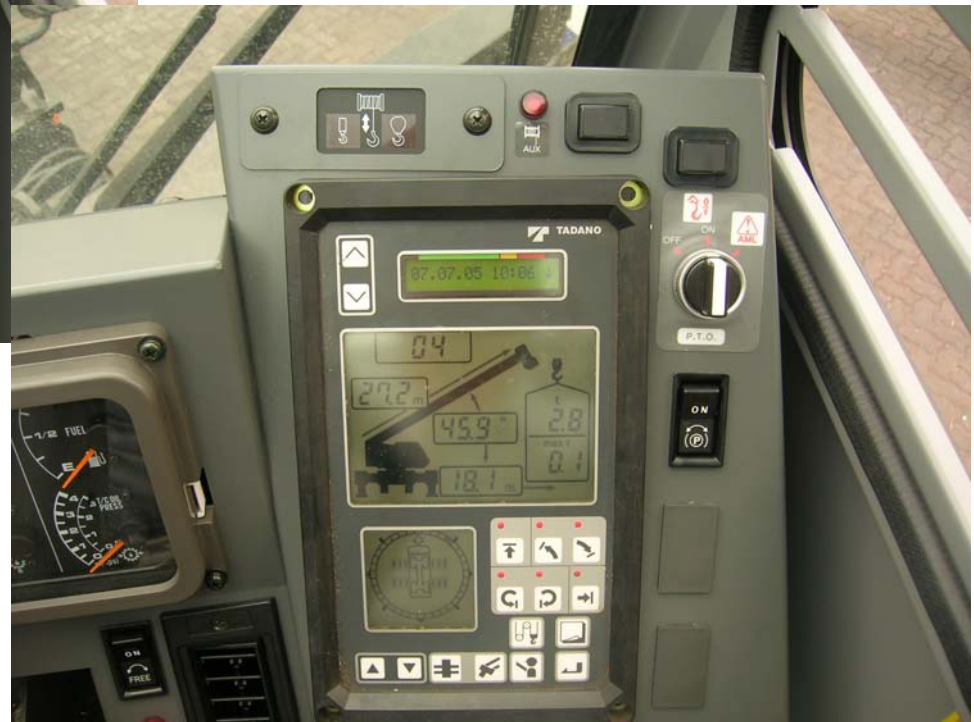
The crane operator had a history of overriding the crane limits and overloading the crane. Shown by computer records from the crane over 40 overloading incidents during October 2007
