**Crane, Rigging & Lifting Committee Meeting**

# **Double Fatality Crane Collapse**

# OSHA Inspection Activity

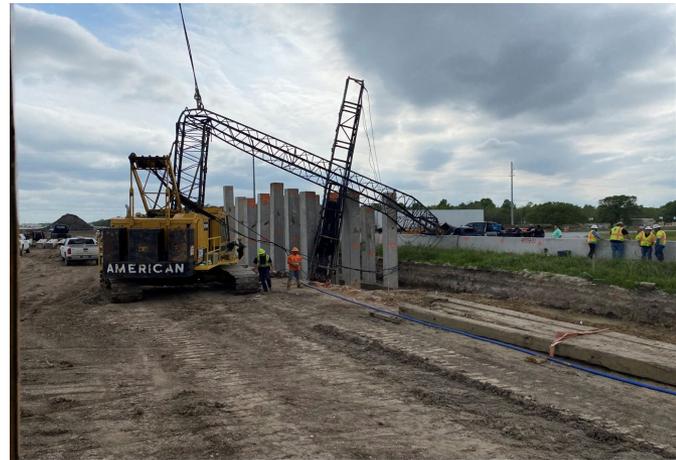
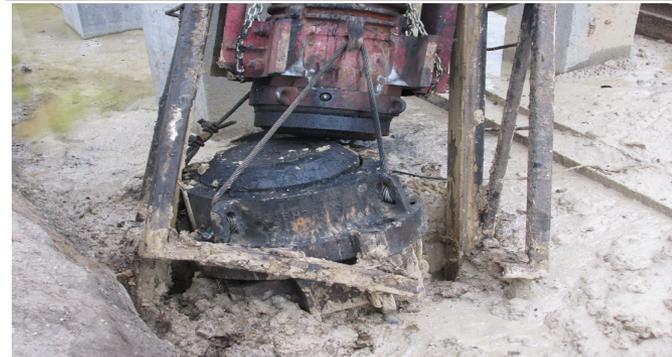
- Finished driving the concrete pile into the ground.
- Part of the box helmet was buried in dense mud.
- Using crane to remove the box helmet.

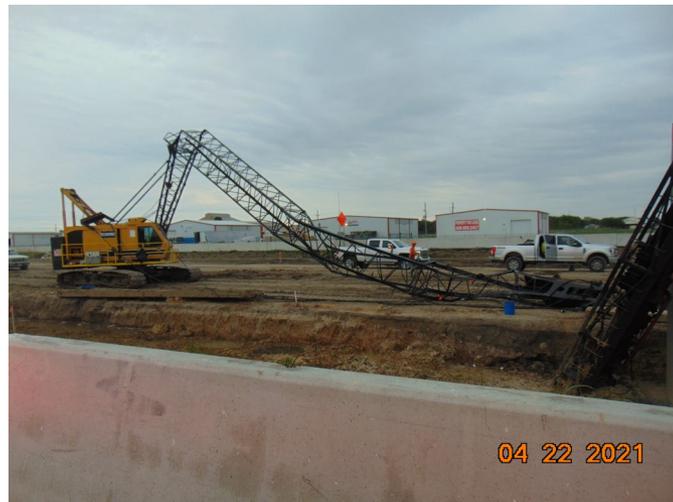
- DPS preliminary conclusion: Crane “malfunction”
- OSHA Conclusion:
  - Failure to assemble a crane boom properly
  - Failure to determine the correct weight of the load, causing overloading
  - Side pulling a load

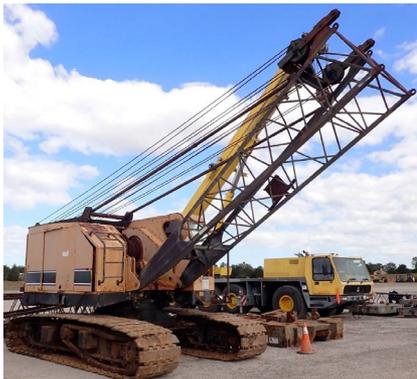
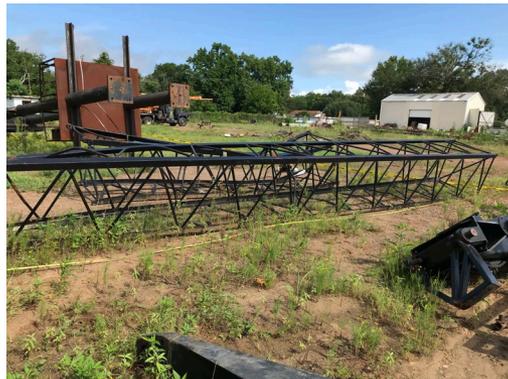
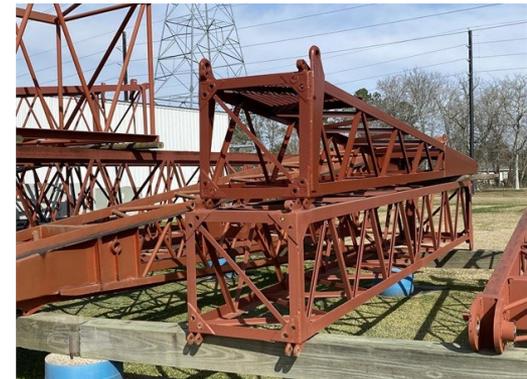
Length	Inner Section	Center Section	Center Section	Outer Section
Manufacturer Configuration	20 feet	20 feet	40 feet	20 feet
Employer Configuration	20 feet	40 feet	20 feet	20 feet

- Follow OSHA's crane and derrick regulations
  - Assembling the crane based on manufacturer specifications
  - Determining a load by weighing each pile driving piece of equipment
  - Operating a crane within its capacity
  - Lifting objects directly under the tip of the crane boom

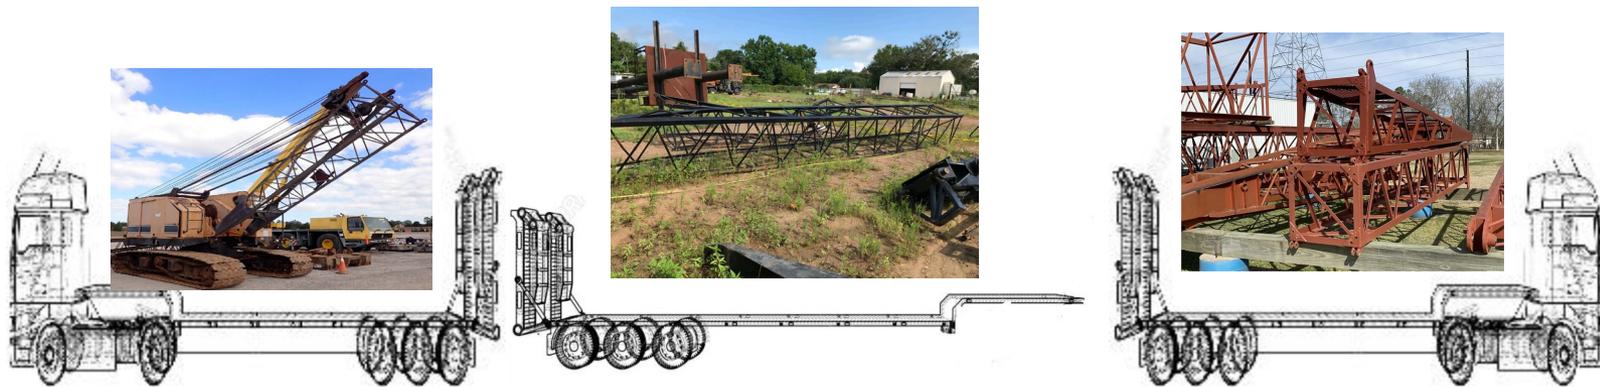
- Convenience: Save time, and money
- Owner experience: Configuration used multiple times without incident

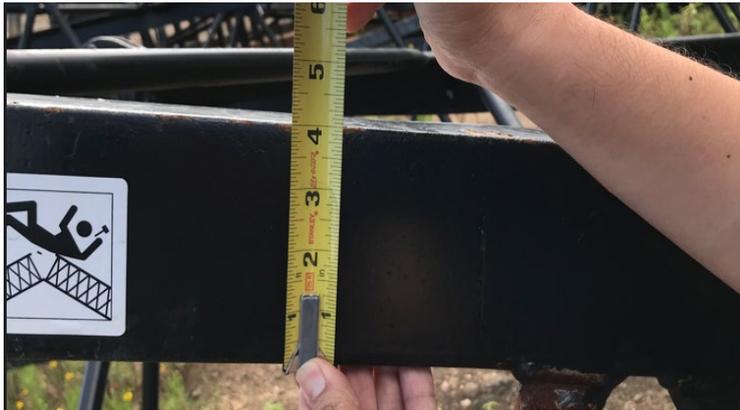
**Heavy Duty- HR (4")**

- OSHA investigation: Reviewed crane repair records
  - 40-ft buckled section: SR
  - Other 20-ft sections: HR

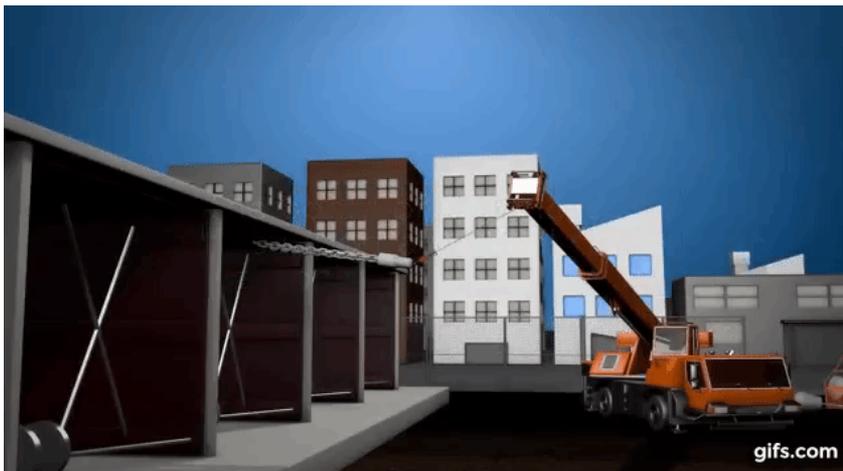
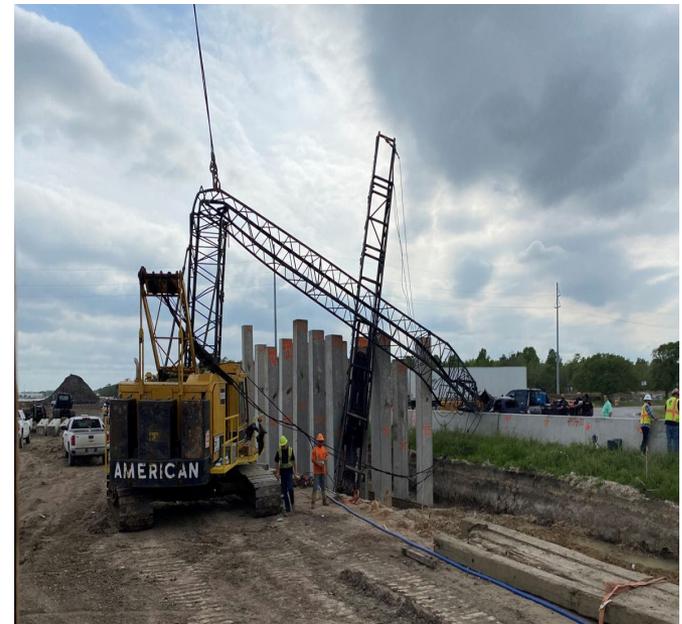
- Load was to the side of crane cabin.
- ASME B30.5, Section 5-3.2.1.5- Prohibited Practice
