FATAL CRANE INCIDENT 22nd October 2007

Germano Construction Site Brazil

LESSONS LEARNED

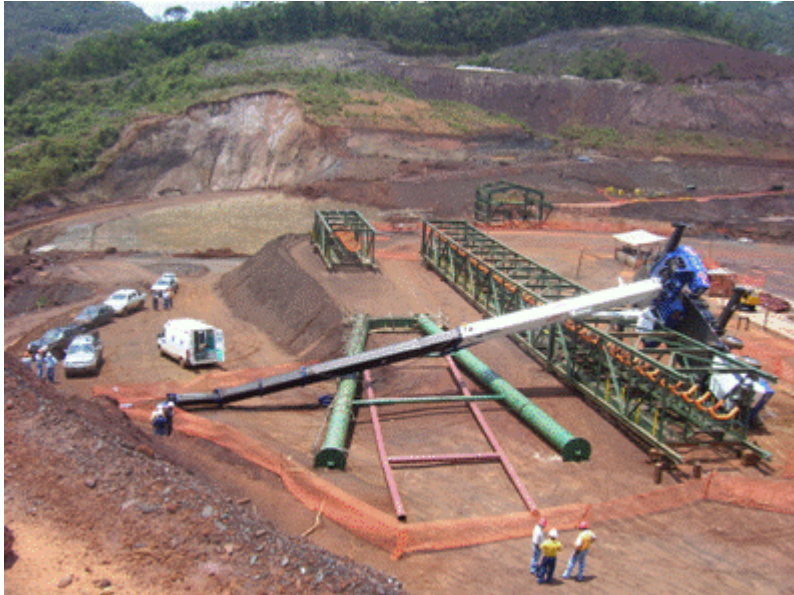
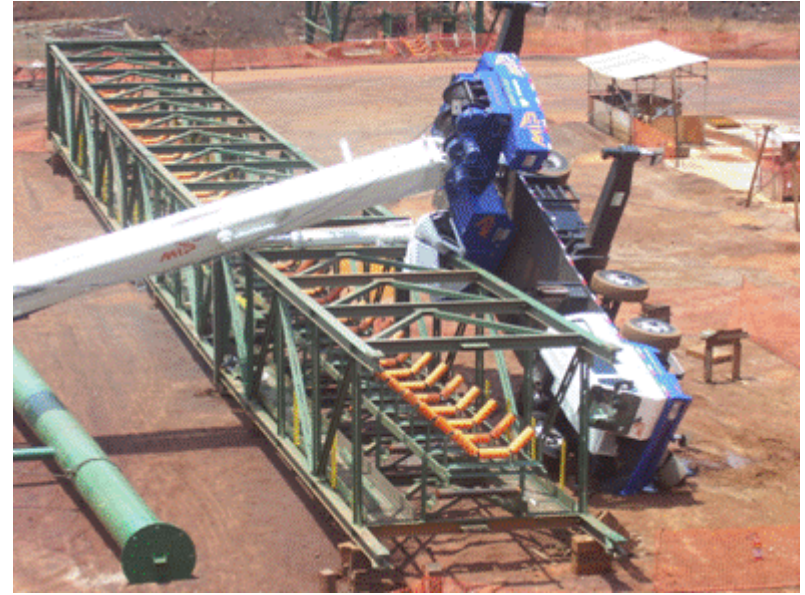
Crane falls over onto its side with the head of the boom resting on the ground, the middle of the boom resting on the conveyor gallery and the cab crushed against the conveyor gallery.

- **The crane was out of radius for its set up and the weight of the load;**
- **The automatic safety interlocks for the crane operation were immobilised at the key outside of the operators cab and the crane operator deliberately overrode the crane limits from the manual switch in the cabin.**
- **There was no Rigging Plan in place for the lift;**
- **Wrong crane used for the lifting task;**

1.	The computers in all site cranes (where fitted) have their data downloaded to investigate if the overloading of cranes is a general violation or restricted to this crane operator.
2.	Emergency bypass controls are to be locked in the off position at all times.
3.	Crane operators are to ensure that the all emergency bypass controls are locked in the off position at the Start of each shift.
4.	Supervision is to inspect all emergency bypass controls during each shift to ensure they are locked in the off position.
5.	Crane operational data from the onboard computer is to be downloaded each month to review the safe use and operation of the crane for the month.
