**Crane, Rigging & Lifting Committee Meeting**

# **Double Fatality Crane Collapse**

# OSHA Inspection Activity

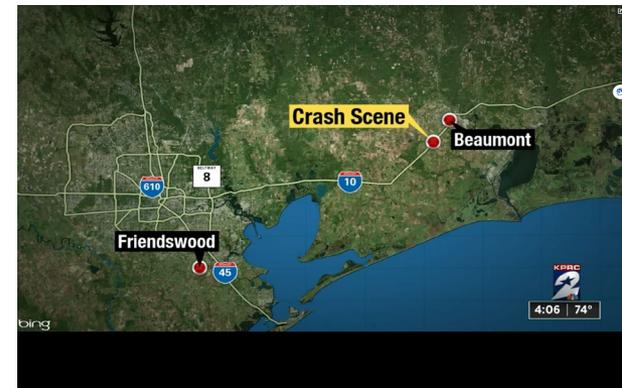
## Two Friendswood men killed after crane falls into traffic along IH-10 just west of Beaumont Thursday

DPS Troopers received reports about the crash around 4:30 p.m. Thursday.

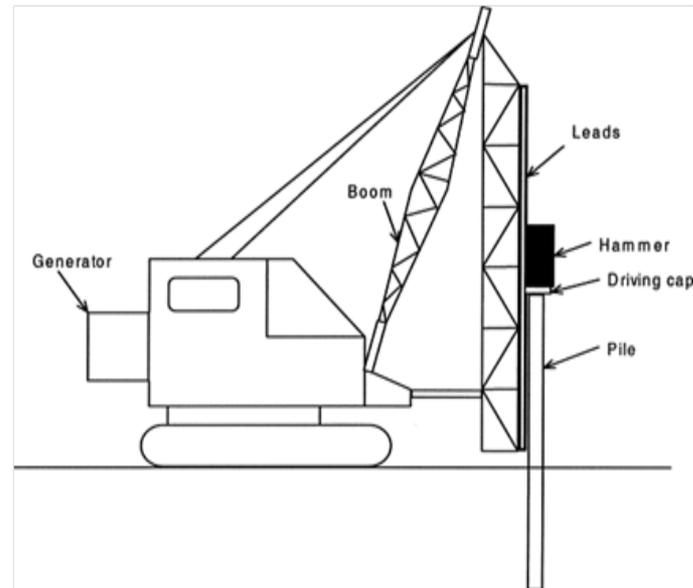
- A crawler-mounted crane
- Hammer
- Hammer Rails or Leads
- Two-piece box helmet or 24-inch driving cap

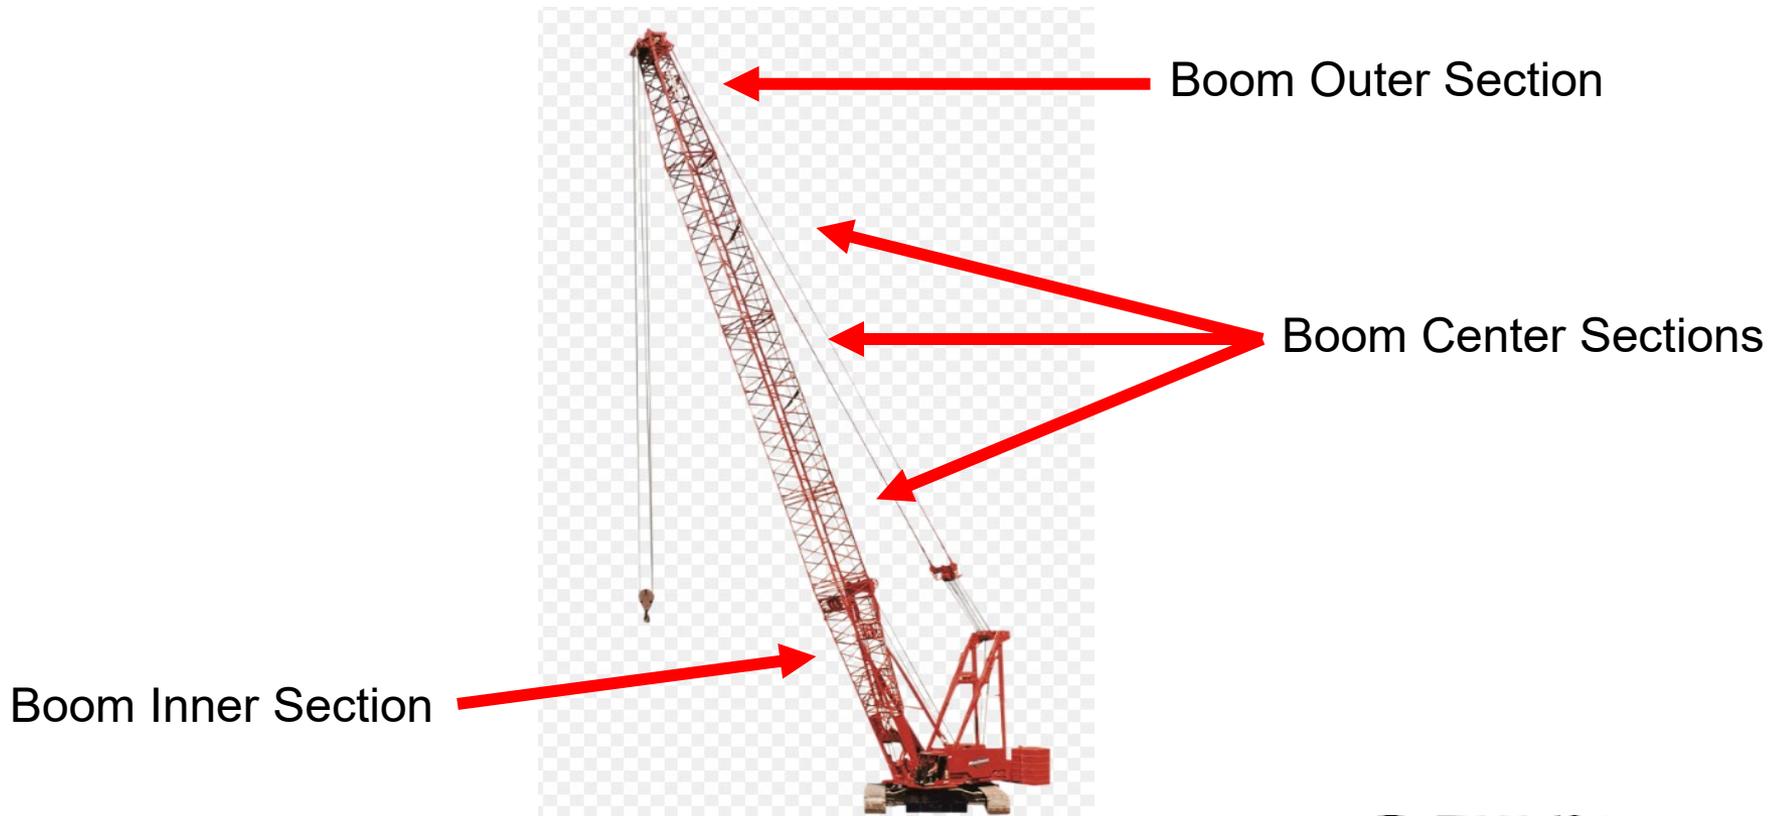
# Crane Boom Schematic

- DPS preliminary conclusion: Crane “malfunction”
- OSHA Conclusion:
  - Failure to assemble a crane boom properly
  - Failure to determine the correct weight of the load, causing overloading
  - Side pulling a load

Length	Inner Section	Center Section	Center Section	Outer Section
Manufacturer Configuration	20 feet	20 feet	40 feet	20 feet
Employer Configuration	20 feet	40 feet	20 feet	20 feet

- Follow OSHA's crane and derrick regulations
  - Assembling the crane based on manufacturer specifications
  - Determining a load by weighing each pile driving piece of equipment
  - Operating a crane within its capacity
  - Lifting objects directly under the tip of the crane boom
